## **Proposal Summary: Historic Sculpture Reproduction**

# Building a Life-Sized Model from Original Fragments

# Translating the Plaster Model into Marble

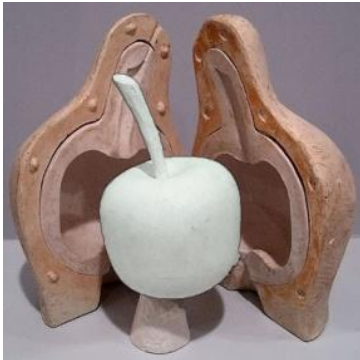
An example of a mold and casting

Due to the weight and the fragile nature of the broken marble fragments, it is not practical to attempt to reassemble them. However we can create copies of the larger pieces by making molds of them, and casting copies in lightweight material. These copies can then be assembled to make a model, which will be a duplicate of the original sculpture.

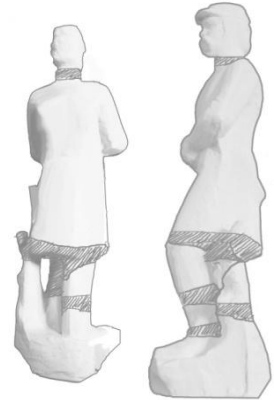
1. Make molds of the pieces of the broken sculpture.
2. Cast the pieces in lightweight, reinforced plaster. Include anchor holes in the bottom of the base.
3. Assemble the pieces to form the statue. Plaster is added to sculpt missing sections, completing the figure.
4. Surface details and losses are sculpted onto the surface with plaster, and finished to match the original photographs.

This will give us a perfect copy of the figure in plaster. The details of the face and the clothing will be restored so that we have an accurate figure for scanning. All that is left is to re-create the gun, and then we will have a complete working model for approval.

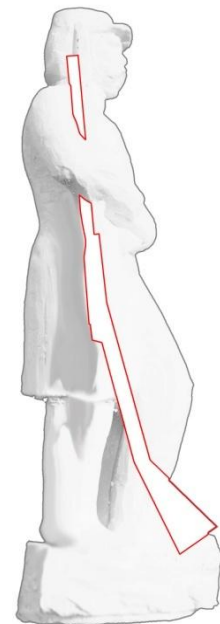
The most efficient method is to use an actual period rifle as a model, to create a properly sized copy out of wood and plaster for detail. The gun will be integrated into the plaster model composition.

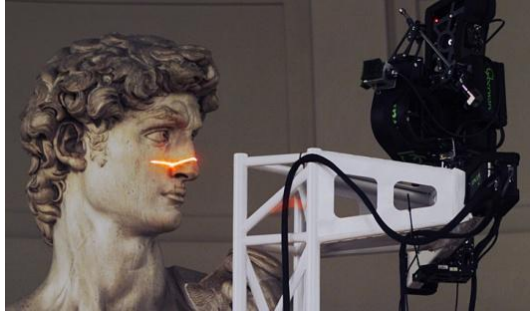
A team from Stanford University utilized 3D scanning technology to document Michelangelo's sculptures and architectural creations.

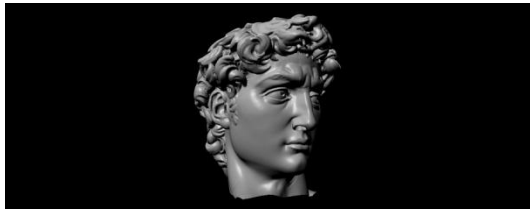
The 3d scanner will record the shape and surface of the model.

3D scanning records the shape of objects with an accuracy which captures minute detail. We will use the same technology to record the form of the Lincoln soldier model. This data is then used as the guide

Using state of the art three-dimensional imaging, we can capture the dimensions, surface and details of the custom built plaster model. Our model will be actual size, so there will be no scaling of dimensions, eliminating any margin of error associated with resizing the 3d model digitally.

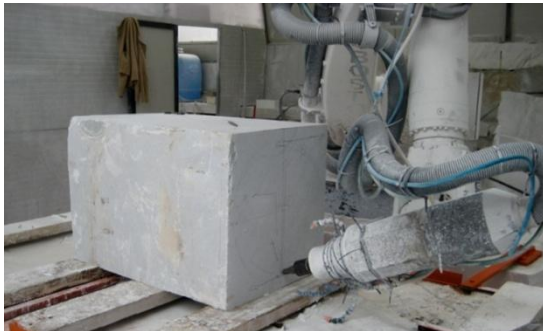
Robot milling makes quick work of reducing a marble block into highly detailed and complex shapes, based on 3D digital matrix information.

Marble carving, hammer and chisling by hand, is an excellent sculptural practice, but for contemporary restoration, we have much more accurate and non-invasive methods to carve stone. Robotic milling machines, essentially an articulating arm with a spindle grinder attached, guided by a computer "brain". These devices replicate three-dimensional computer models by removing material systematically, and without hammering, which can damage the internal matrix of the stone.

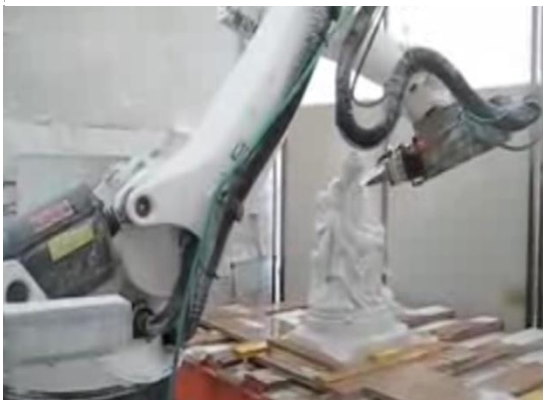
Marble carving robot finishing a sculpture

Working with a carving studio in Carrara, Italy, who operate a robot specially designed to carve marble, we can have our model translated into Carrara marble, as the artist of the original soldier, intended. When completed and hand finished, the carving will show no traces of the robotic carving method, aside from the amazing perfection in the exactness of the reproduction.

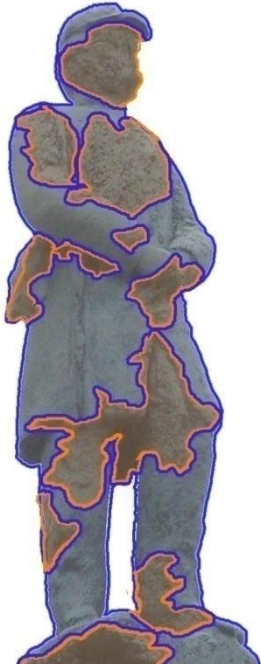
**The areas highlighted in orange are deeply decayed; the sections in blue have their surfaces intact, as they would be after 140 years of exposure. These localized patterns of decay do not suggest natural weathering.**

Outdoor marble sculptures, when not periodically cleaned, develop black stains over time. These "stains" happen on the forms, where rain water does not wash away atmospheric soiling, and eventually black crusts form. The illustration on the left shows the sections which are deeply decayed (orange), while others are much less so (blue).

The deeply decayed sections correspond with the locations where the aforementioned crusts would have formed. If these crusts had been removed with an acid, such as muriatic (hydrochloric) acid, this would explain the localized and excessive decay. It is not uncommon for this type of acid to be used in masonry. Hydrochloric acid as a solution destroys the binders of the marble, and, when dry, soluble salts become deposited within the stone, causing continual excessive decay with each re-wetting of the stone. This would explain the loss of the rifle element to decay, as well as the weakening of the proper right leg. The leg section decayed, it eventually submitted to the weight of the torso, resulting in the fallen statue.

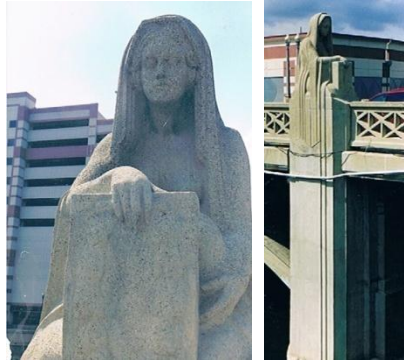
Damaged sections were recreated with a custom mortar, matching the cement color and aggregate type to simulate the original.

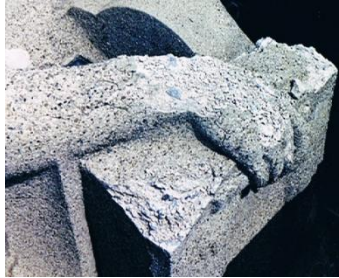
Many sections of the 4 sculptures suffered losses and were in a friable state. I was able to remove loose crumbled cement, down to the sound cement below, before reconstructing the losses.

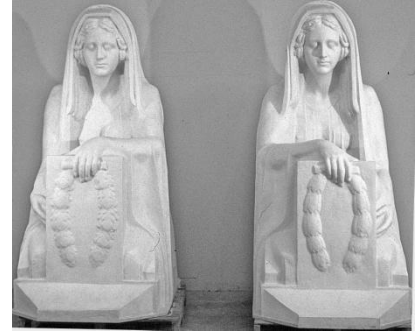
I made molds of the restored bridge sculptures on site, and cast these full size (9 foot tall) archival models of reinforced polyester resin for the City of Aurora, in case the originals eventually have to be re-cast.

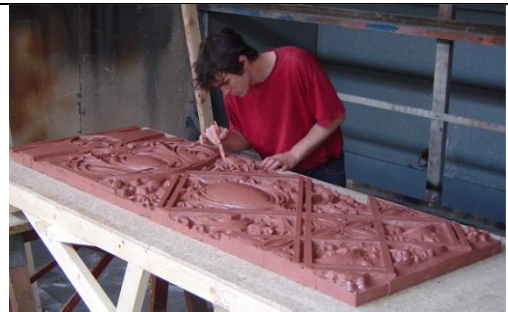
Each panel was sculpted by hand in oil clay, a mold was made for each, and plaster positives were finished by hand. This panel is 6 feet tall.

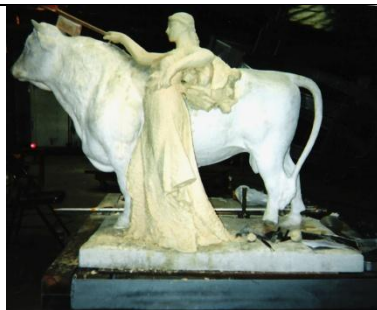
The bull and base were cast directly from the sister sculpture, the figure was hand built by me, with a foam core and oil clay skin for detailing.

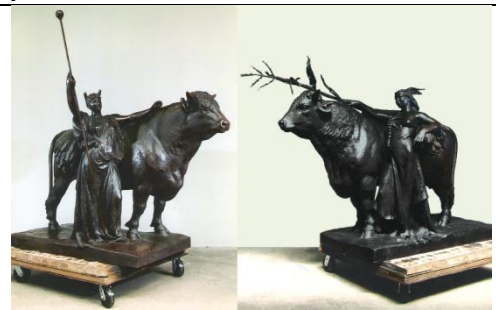
The new sculpture was cast in bronze and installed with its sister sculpture on their bases at the Garfield Park Conservancy, in Chicago, Illinois.
